Manhole Inspection Summary

Manhole # S03AA2003MH

Insp Date: **8/9/06 9:03 AM**

Location Address: **6100 CROSS COUNTRY BLVD**

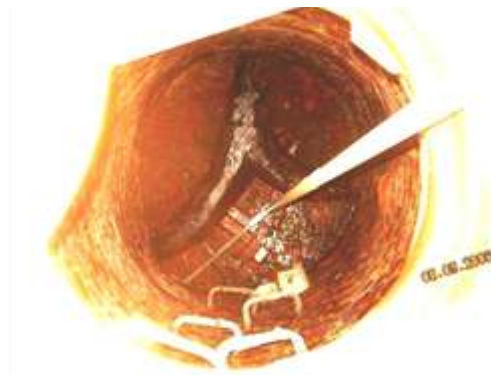
Top View

Condition: ☐ Sound ☐ Cracked ☐ Root Intrusion ☒ **Loose Brick** ☐ Deteriorated

Infiltration: ☐ None ☒ **Joint** ☐ Cracks ☐ Mortar ☐ Roots ☐ Wall

Infiltration: ☐ None ☐ Joint ☐ Cracks ☒ **Mortar** ☐ Roots ☒ **Wall**

Count: **5** Missing: **0** ☒ **Corroded**

Adjustment loose brick and infiltration.
Barrel infiltration. Corroded steps. Bench
debris.

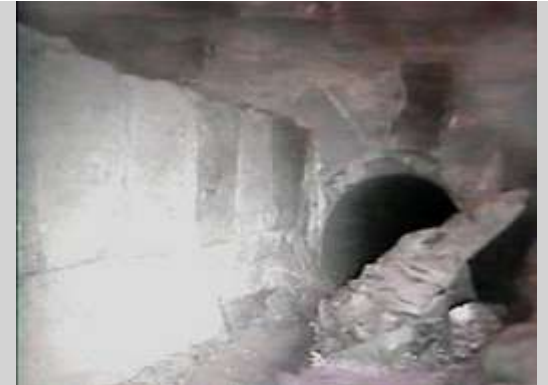
6 in. Circular Gravity Sewer Pipe Out @ 12 O'Clock

Deposits: ☐ None ☒ **Mud** ☐ Sludge ☒ **Debris** ☐ Grease

Silt Depth: **2** (in.) Deposits Extent: **Heavy**

Infiltration: **Evidence** Pipe Seal Cond: **Unknown**

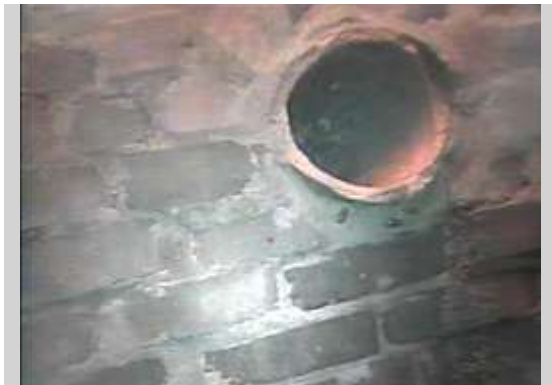
6 in. Circular Gravity Sewer Pipe In @ 3 O'Clock

Infiltration: **Evidence** Pipe Seal Cond: **Unknown**

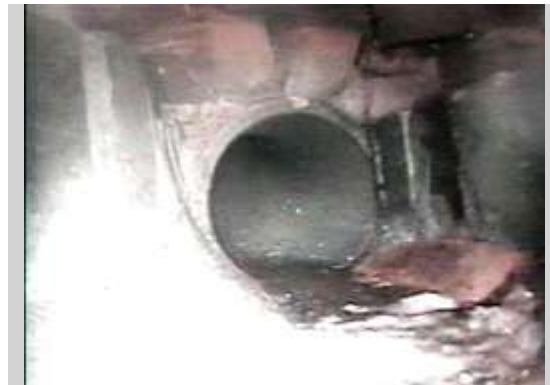
Drop In @ 3 O'Clock

Drop Condition: **Open**

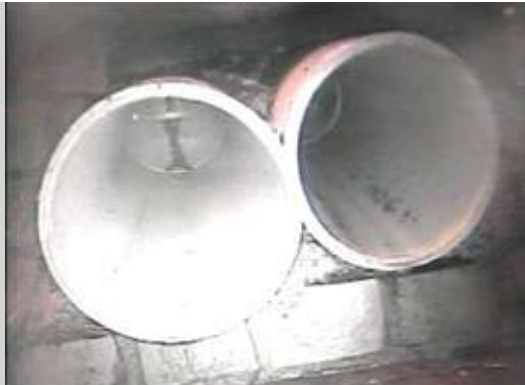
Pipe In @ 6 O'Clock

Infiltration: **Evidence**

Pipe Seal Cond: **Broken**

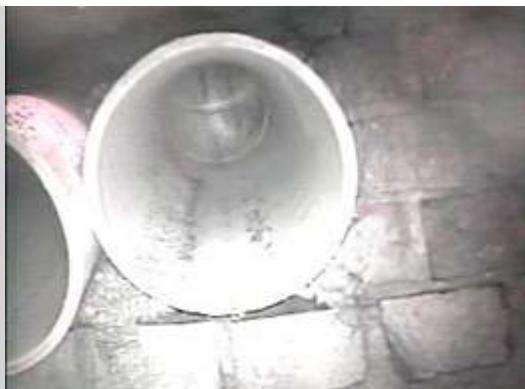
Pipe In @ 7 O'Clock

Infiltration: **Evidence**

Pipe Seal Cond: **Broken**

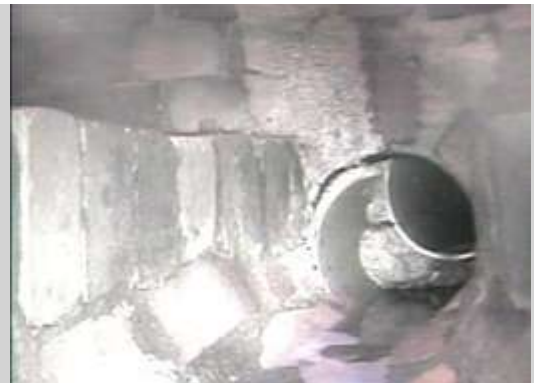
Pipe In @ 8 O'Clock

Barrel infiltration.

Pipe Seal Cond: **Broken**
